# **Field Report for Airborne Data Collected In Support of US EPA Region 6 Intercontinental Terminals Company LLC Fire 19 April 2019**

## **Data Results Flight 27, 19 April 2019**

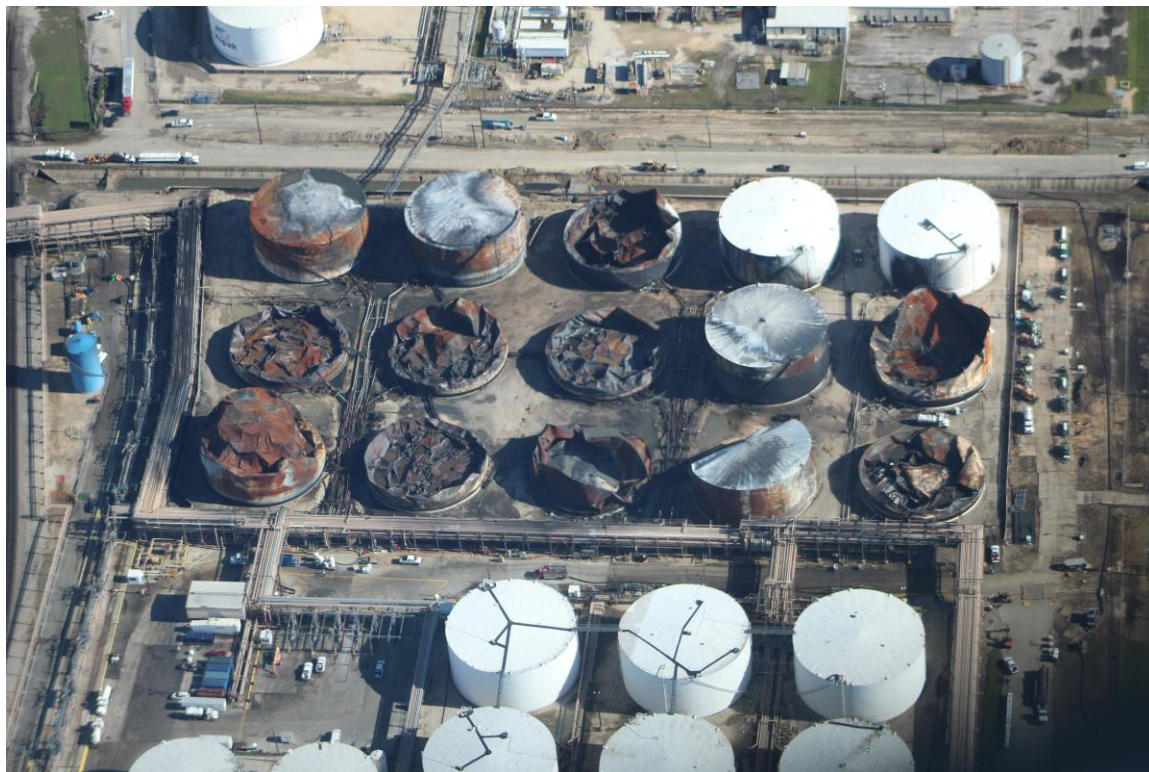
A full set of high resolution aerial digital photography was collected as part of the flight. Figure 5 shows representative overhead images collected as part of each pass over the tank farm. No change from previous flights was observed in the image. A similar conclusion is reached based on the oblique imagery (Figure 6).

Figure 6: Oblique Image of the Tank Farm (looking toward the North), 19 April 2019 Flight 27

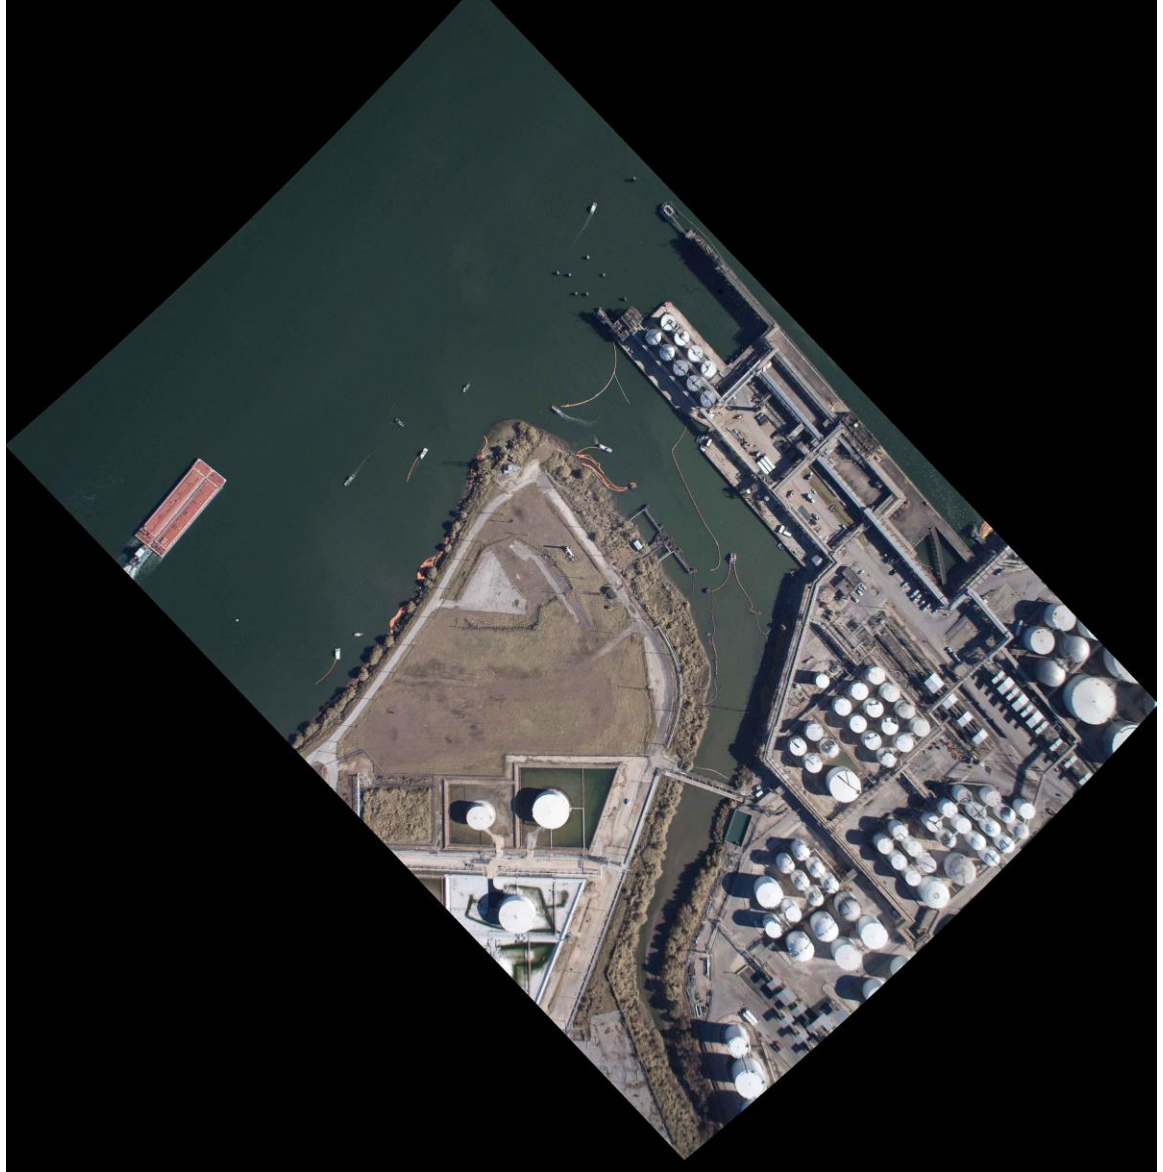
Figure 7 shows an overhead aerial image of the confluence area along the ship channel. As noted with the analysis of the IR image, the boom network in the area has been

removed. A few clean-up booms are present in the drainage channel and being towed by boats can be seen. No product or sheen evident in the image. An oblique image collected over the same area (Figure 8) confirms this conclusion.

Figure 7: Aerial Image of the Ship Channel Boom Area, 19 April 2019, Flight 27

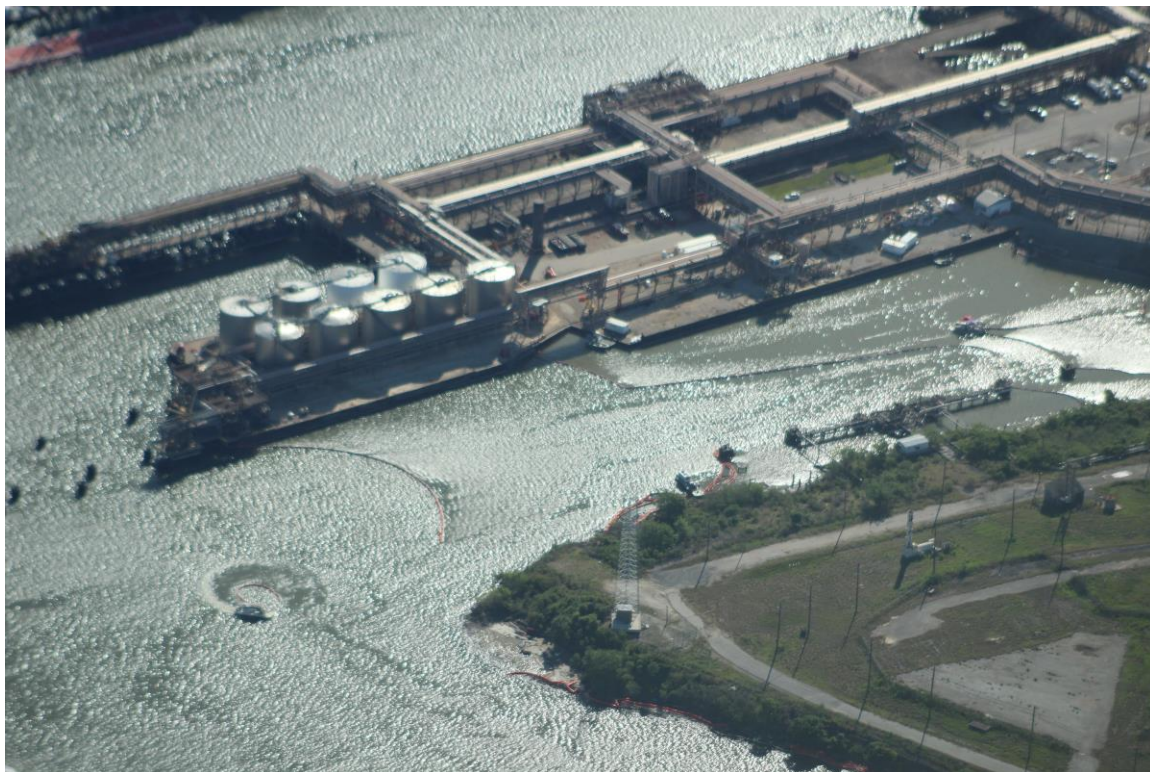
Figure 8: Oblique Image of the Ship Channel Boom Area, 19 April 2019, Flight 27
